# MAAPによる1～3号機の 事故シーケンスの詳細解析について

Detailed analysis of the accident progression  
of Units 1 to 3 by using MAAP code

平成24年7月23日

東京電力株式会社

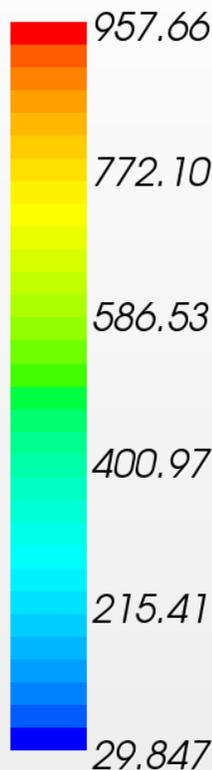
# 7. (参考)空冷の場合のCFD評価

Temperature (C)

x-z方向  
温度分布

x-y方向温度分布

CFD評価により、空冷のみの条件  
であっても、最大960°C程度の温度  
となると評価

(保守的に1500W/体にて評価)

水がない場合でも、空気冷却で  
崩壊熱分の除熱がなされるとの、  
MELCOR解析、MAAP解析と  
ほぼ同等の結果となっている。

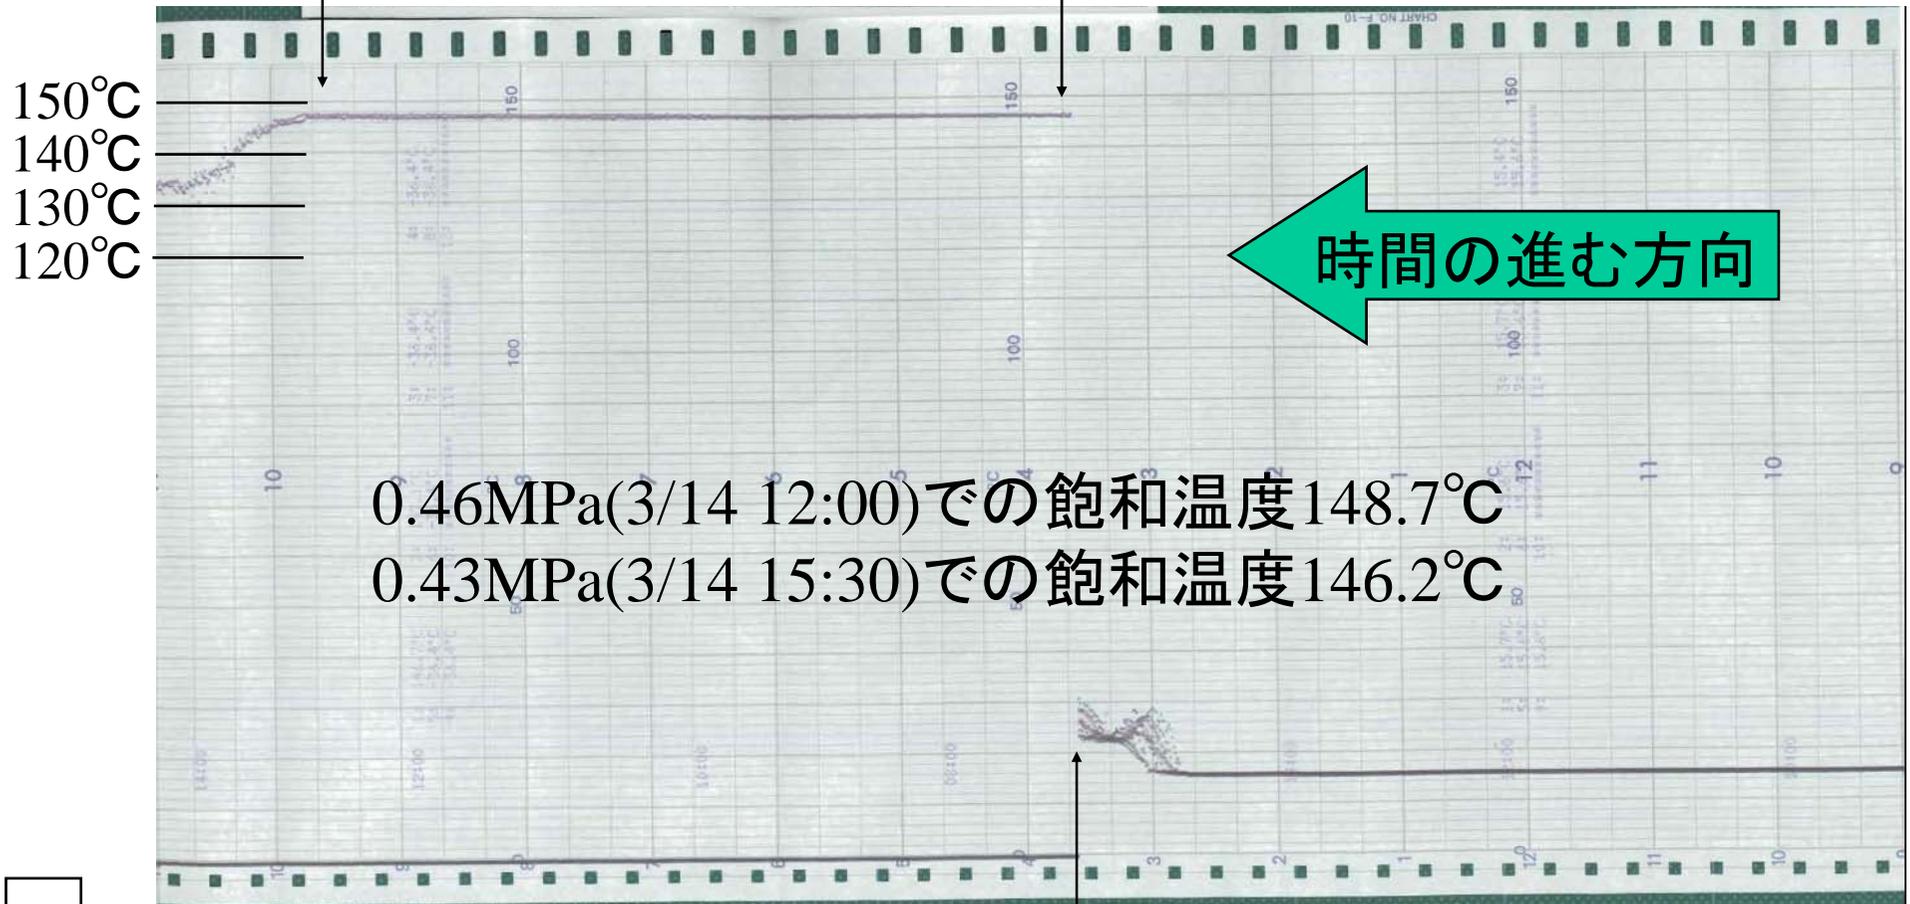
# チャート(S/C 温度)

概ね13時頃

記録計再起動3/14 概ね7時頃
